## Introduction

## How defect assessments are conducted

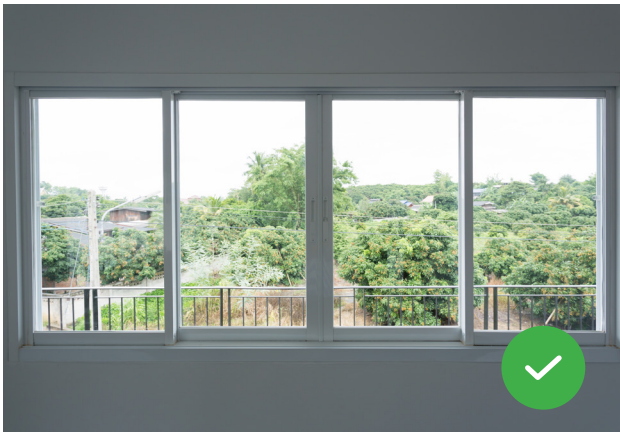
**Image: Correct viewing position**

- Glass should not be in direct sunlight during the inspection.
- There may be minor variation based on State-Based Legislation or contractual conditions.
- Not only is the viewing distance and angle important, so to is the type of daylight you're looking into. Certainly, the glass can be viewed in the daylight, but it must not be direct sunshine.

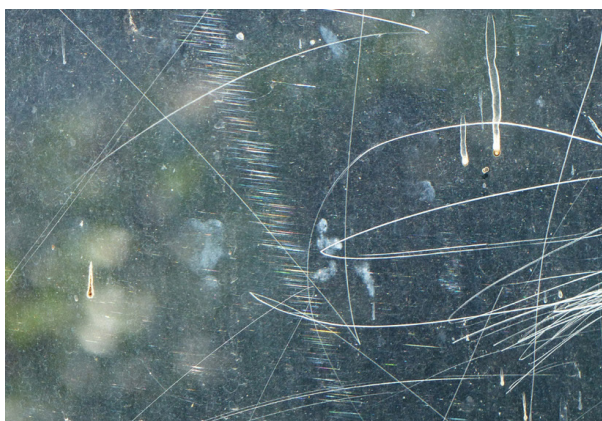
**Image: Scratches on Glass**

Surface scratches on the glass are, without a doubt, the most common problem. A sharp or rough instrument may cause marking or tearing of the glass surface.

In respect to as Low-emissivity (Low-E) glass the coatings are actually harder than the glass and consequently is quite difficult to scratch. However, the marks might be abrasion marks. The consequence of the coating being very hard is that it can abrade other materials. So, materials rubbed across the coating can abrade and leave deposits on the surface. These abrasion marks can be cleaned off using the manufacturer's recommended procedure.

Scratches should not be visible from 3 meters or more. For the maximum allowable number of scratches in primary and secondary vision of IGU refer to Table 5.5 and 5.6 of AS 4666.

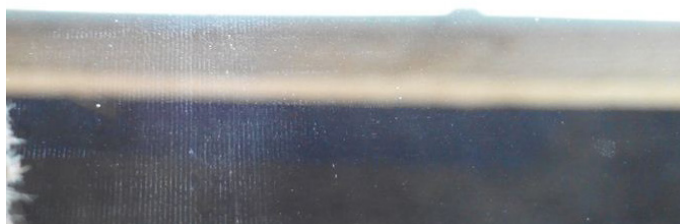
**Image: Haze on Glass**

Haze (a light and milky effect) is the scattering of light rays when visible light passes through a transparent material like glass. Haze can appear on coated glass such as Low-emissivity (Low-E) or laminated glass or tinted glass. The amount of haze in ordinary glass is very low and is not detected by the human eye. Haze is a characteristic that is a common consequence of the crystalline structure of the coating. Some of the light that enters glass is absorbed, and some scattered by components within the glass. If sufficient light is scattered, then it will appear as a haze in the glass. The visibility of haze depends on two criteria: the surrounding conditions and the brightness of the background.

It is possible for a glass product to exhibit haze at certain times of the day and not at another. It is also possible for the same type of glass to display haze in one location and not in another. With any coated glass, it is possible to see the presence of the coating under a certain angle and intensity of the lighting. Haze sometimes has the appearance of a blue-grey film or dust on the coated glass. Haze can occur in both clear and coloured laminate, with it more evident in grey laminate. Haze is very dependent on the angle and intensity of the light. Some colour variations such as a blue haze may exhibit in Low-E glass, especially noticeable if part of the glass is shaded.

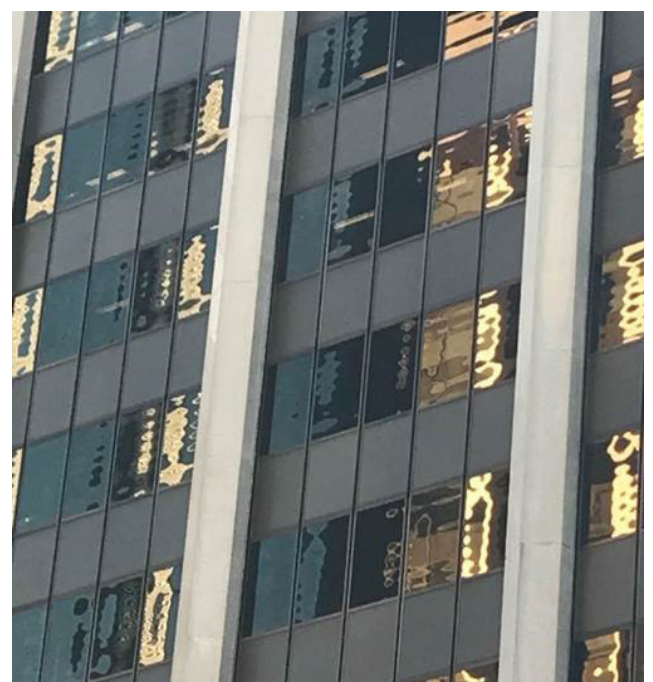
**Image: Roller wave on building windows**

Roller wave can be seen in toughened and heat-strengthened glass. Glass is generally toughened in a horizontal roller hearth furnace, where glass is carried through and oscillated on ceramic rollers under high heat (approx. 600°C) at this temperature glass starts to soften and can therefore creep between the rollers causing alternating high and low points resulting in the glass exhibiting optical distortion.

This distortion is more noticeable in reflective or dark tinted glass. This distortion is also more noticeable in thinner toughened glass, for example The roller wave distortion is more visible on 4 mm toughened glass than say 6 mm toughened glass.

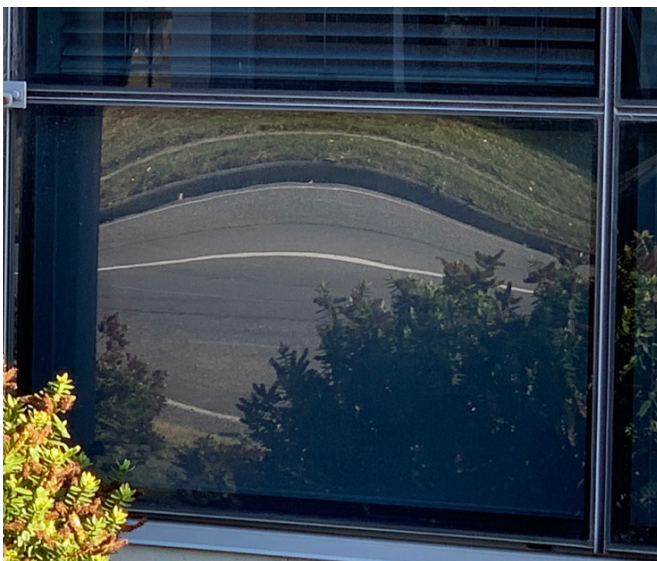
Small changes in temperature and pressure can cause the glass to bow outwards or inwards and change the images reflected from the window, as shown in the image on the right. These distortions are unavoidable and cannot be eliminated. The use of thicker glass will reduce glass deflection under wind loads.
